INSPECTION PERFORMED BY

LaCama Payne (SC License# 47917) Pearl Property Inspection LLC

Brick Run, Augusta, Ga 30909

Sample_Pearl210001_###Brick Run

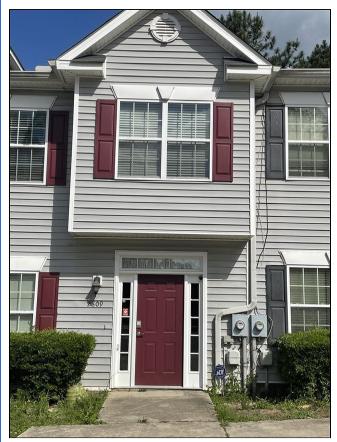
1.0 Item 1 (Picture) Front Exterior

I observed vinyl siding on the exterior front and rear of home. I observed minor deflection in the vinyl siding However, it appears to be satisfactory. Recommend monitoring to identify additional changes in overall observed condition of vinyl siding.

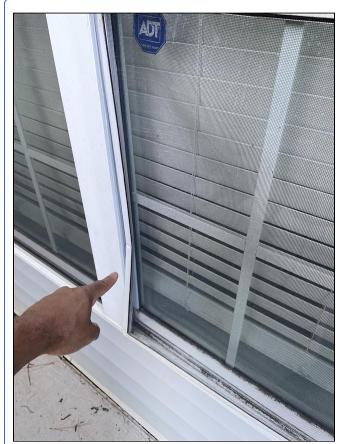
1.2 Item 2 (Picture) Front screen missing

1.2 Minor Defect: I observed a screen missing from the front window(living room) and I observed damage to a screen located on the rear exterior of the home(dining room/kitchen area). Recommend replace broken and missing screens.

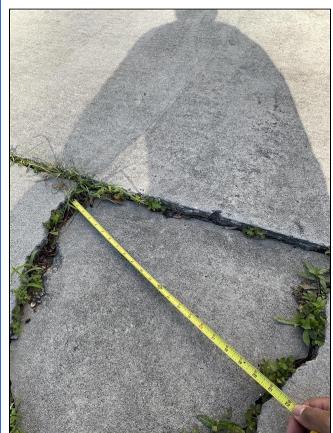
1.4 Item 1 (Picture) Driveway hazard 1

- (1) Safety Hazard: (Major Defect) I observed excessive cracking and settling of the concrete driveway measuring more than 1/4 inch wide. The settling and cracking poses a trip hazard. Recommend contacting a general contractor or structural engineer to evaluate further and repair as necessary to correct deficiency.

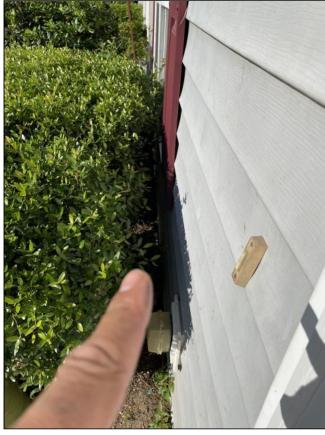
1.4 Item 4 (Picture) vegetation

vegetation located in the front of the home too close to the exterior vinyl siding. Vegetation should be properly maintained and at least 1 foot away from building or foundation to prevent moisture retention and allow for maintenance. Recommend trimming to allow adequate clearance from home.

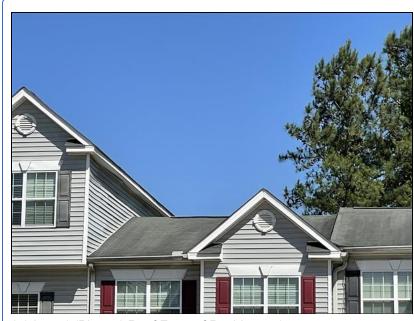
2.0 Item 1 (Picture) Roof Front of Residence 1

2.0 Observed very small area of visible asphalt roof covering from the ground with binoculars. Unable to determine the overall condition and age of the roof covering due to height of roof from ground. Recommend having a certified roofer to evaluate condition of roofing material.

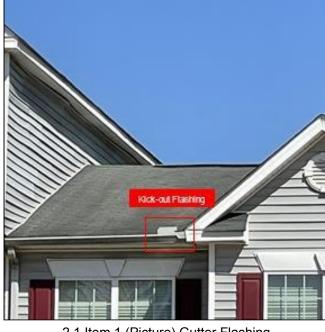
2.1 Item 1 (Picture) Gutter Flashing

2.1 I was able to observed kick-out flashing adjacent to the valley of the roof. I was only able to observe the presence and not the condition of the flashing. From the ground it appears to be satisfactory. Recommend further evaluation by certified roof or gutter specialist to determine the condition and correct any defects if necessary.

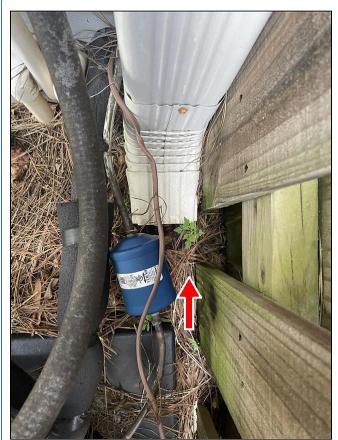
2.4 Item 2 (Picture) Exterior Downspout

- (1) Minor Defect: The gutters are full of debris in areas and needs to be cleaned. It appears vegetation is beginning to grow as a result of lack of maintenance/dirt. The debris in gutters can also conceal rust, deterioration or leaks that are not visible until cleaned, and I am unable to determine if such conditions exist. Recommend cleaning gutter remove debris
- (2) Major Defect: The gutter downspouts need splash-blocks or tray (concrete or plastic) at the front and rear of home. Splash-blocks or down spout extensions should discharge water at least 5 feet away from the foundation. Recommend repair to correct defect.

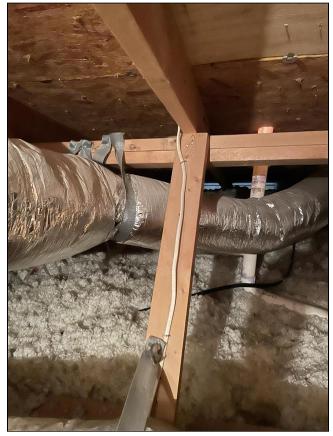
2.7 Item 1 (Picture) Insulation 1

I observed the insulation is blown loose fiberglass and is measured less than six inches in depth(R-19) throughout various areas of the attic space. Insulation is providing inadequate coverage. Heat loss can occur more on this home than one that is properly insulated Insulation. Also, insulation that has settled does not perform to the R-value that it once did. I recommend having a certified insulation professional add adequate insulation.

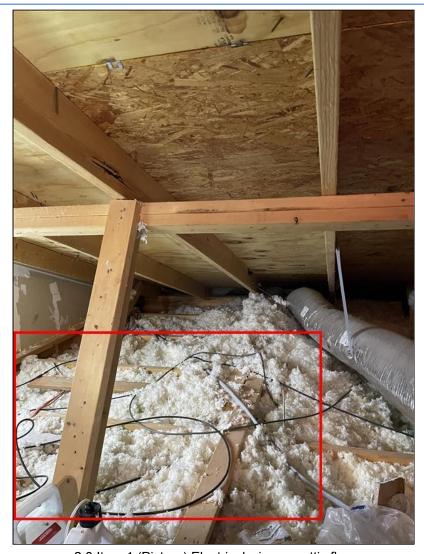
2.8 Item 1 (Picture) Electrical wires on attic floor

wiring in attic was not secured to wood members properly, and was not installed neatly or in 90 degree turns as in standard workmanlike practice. This may indicate that a licensed electrical contractor did not perform the work or did not follow standards. Recommend an electrician properly secure lose wires.

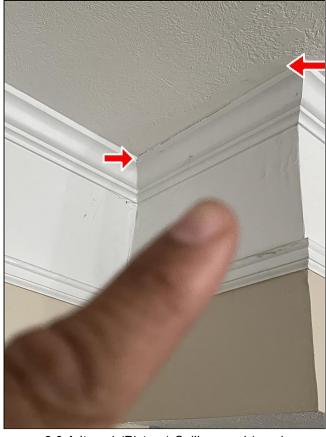
3.0.A Item 1 (Picture) Ceiling crack/repair

3.0.A Minor Defect: I observed repair and small cracking where the wall and ceiling meet near the crown molding. It appeared this area was repaired. No determination made as to the cause of the cause of the cracking. Recommend monitoring to observe and movement or additional cracking.

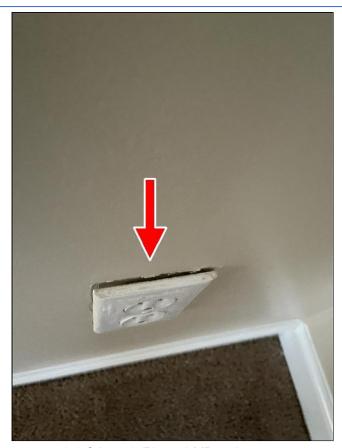
3.6.C Item 1 (Picture) MB outlet cover

Q 3.6.C (1) Safety Hazard: I observed outlet cover lose. Lose outlet cover poses an electrical shock hazard. I recommend repair and/or replacement of outlet cover/receptacle to correct deficiency

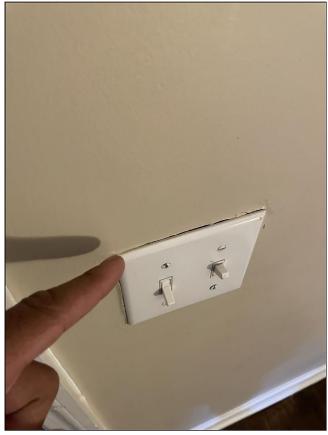
3.6.C Item 2 (Picture) Top of Stairs (near MB)

3.6.C (2) Safety Hazard: I observed light switch cover lose. Lose light switch cover poses an electrical shock hazard. I recommend repair and/or replacement of outlet cover/receptacle to correct deficiency

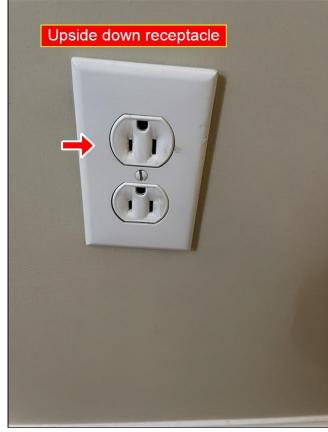
3.6.E Item 1 (Picture) Receptacle (Guest 2)

3.6.E Safety Hazard: I observed outlet installed upside down. I tested the outlet to ensure proper polarity and it was not indicating any wiring concerns. I recommend repair and/or replacement of outlet cover/receptacle to correct deficiency

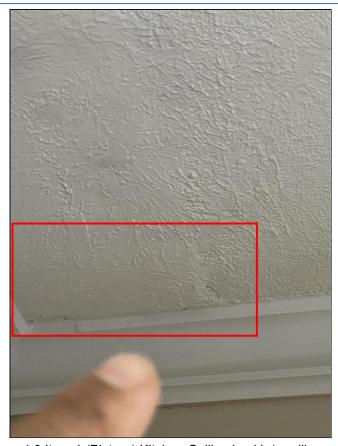
4.0 Item 1 (Picture) Kitchen Ceiling buckle/swelling

4.0 Minor Defect: I observed some swelling and cracking of the ceiling wall. It is unclear of the cause of the defect. Recommend a general contractor evaluate further and repair as needed to correct deficiency.

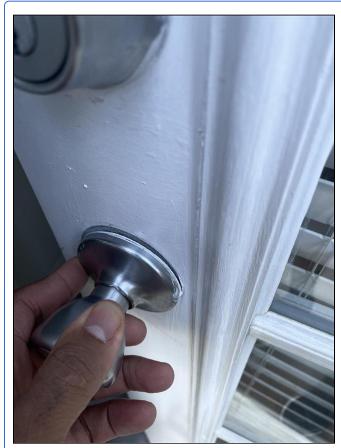
4.3 Item 1 (Picture) Loose door handle (rear entry)

Minor Defect: I observed a loose door handle on the rear entry door and it needs adjustment I recommend repair as necessary to avoid further damage to the closure and security of the door knob/door.

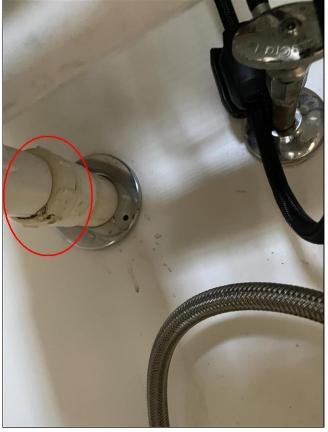
4.6 Item 2 (Picture) Garbage disposal pipe stain

4.6 Minor Defect: I observed evidence of staining on the underneath cabinet floor of the kitchen sink. It appears the leak could be coming from the garbage disposal drain or from the sink drain pipes. I recommend to monitor to determine if the leak is active. Repair as necessary if leak is detected.

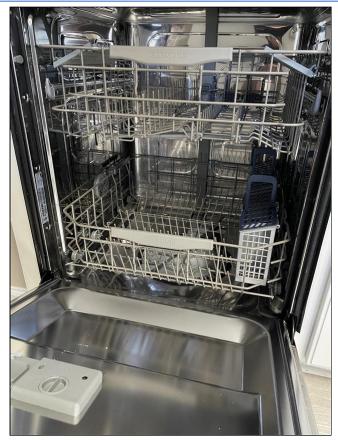
4.9 Item 1 (Picture) Dishwasher

4.9 Monitor: Dishwasher operated with normal controls. Foul odor detected upon opening of the dishwasher. Unable to determine the cause of the smell. Recommend monitoring and running a few cycles to reduce the smell.

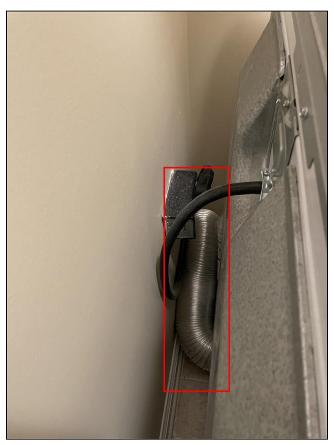
4.15 Item 1 (Picture) Dryer vent

Minor Defect: I observed dust on the lint screen of the dryer and on the exterior dryer exhaust vent on the rear of the home. The venter damper was in place and no signs of damage. Recommend cleaning dryer vents. It is recommended dryer exhaust vents are inspected and cleaned once a year. Lack of airflow may cause dryer to overheat due to build up of lint

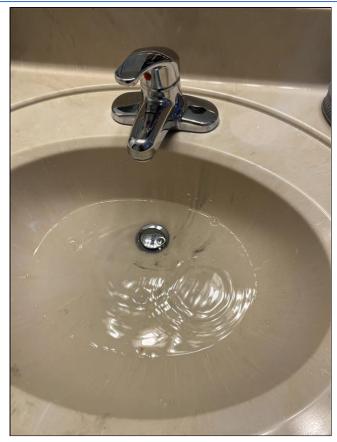
5.6.A Item 1 (Picture) Sink drainage (MB)

5.6.A (1) Minor Defect: I observed poor drainage in Master Bath(MB) sink after running about 4 inches of water in sink. After turning the faucet off, the drainage failed to operate properly resulting in water remaining in the sink for 5-10 seconds before draining. Recommend plumber clear blockage from sink to allow proper drainage.

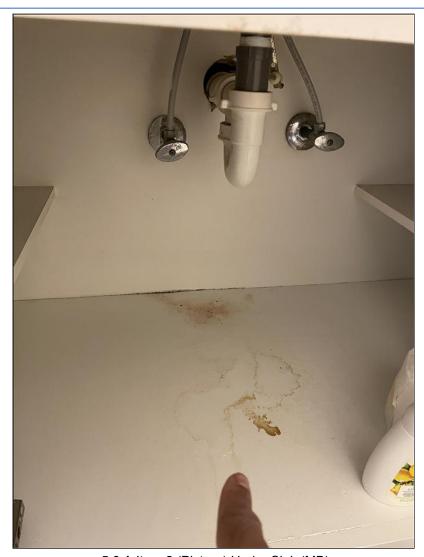
5.6.A Item 2 (Picture) Under Sink (MB)

5.6.A (2) Minor Defect: I observed staining underneath sink which indicated previous leak water presence. I didn't observe any active leaks. I recommend monitoring to ensure no active leaks.

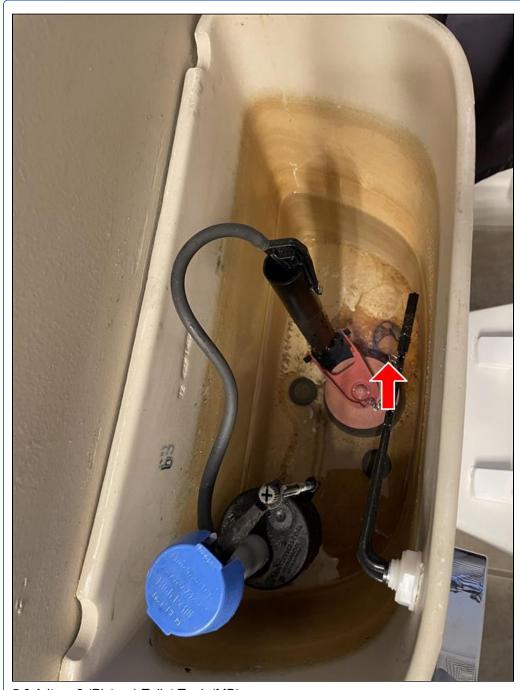
5.6.A Item 3 (Picture) Toilet Tank (MB)

5.6.A (3) Minor Defect: I observed rust forming in the base of the toilet tank surrounding the bolts. I recommend to repair as necessary and continue to monitor for any further rusting or potential leaks that can occur from rusting bolts in the toilet tank area.

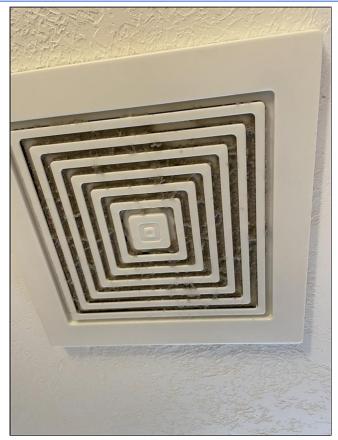
5.9.A Item 1 (Picture) MB vent

5.9.A Minor Defect: I observed dirty exhaust vent in MB. Exhaust vents are vital to removing excessive moisture from bathrooms while showering to allow proper venting. I recommend proper cleaning and regular scheduled maintenance to ensure vents remains free of dirt and dust.

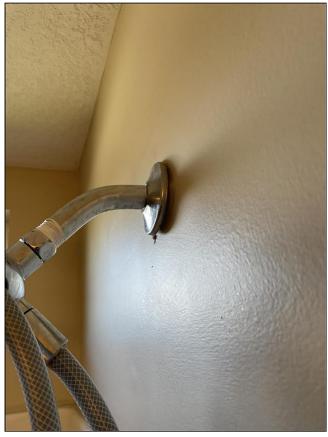
5.7.B Item 1 (Picture) Shower Head (Hall)

5.7.B Minor Defect: I observed shower head housing not sitting flush to the wall. Detached shower head housing could allow water and/or moisture to get within the wall cavity and cause damage to wall and insulation. Recommend repairing to correct deficiency.

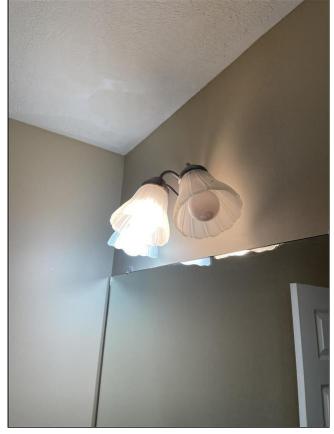
5.8.B Item 1 (Picture) Light out (Hall bath)

5.8.B Minor Defect: I observed one of three light in the Hall bath inoperable. Recommend replacing bulb or repair fixture as necessary.

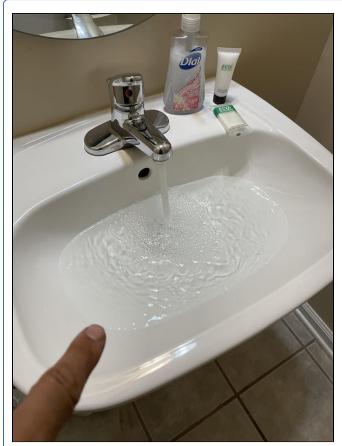
5.7.C Item 1 (Picture) Pour Drainage

- (1) Minor Defect: I observed poor drainage in Powder Room (Downstairs) sink after running about 4 inches of water in sink. After turning the faucet off, the drainage failed to operate properly resulting in water remaining in the sink for 5-10 seconds before draining. Recommend plumber clear blockage from sink to allow proper drainage.
- (2) Powder Room toilet appeared to operate satisfactory.

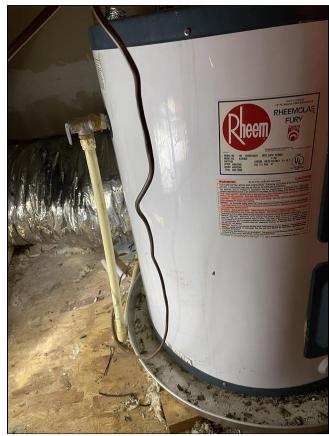
7.2 Item 1 (Picture) Water Heater

7.2 Major Defect: The water heater (Rheem Model # 81SV50D) is located in the attic. It was manufactured on 12/2003 and It is a 50 gal tank capacity. It is old, rusted, and corrosion is active at the hot and cold copper inlet/outlet pipes. The water heater is at the end of its life expectancy. No leaks at present. A replacement is needed. I recommend a licensed plumber inspect further and repair as necessary.

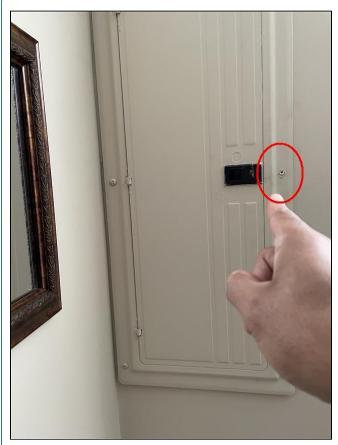
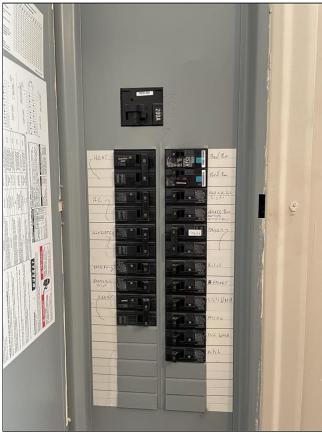
8.7 Item 1 (Picture) Main Panel

Major Defect: I observed incorrect screws (bolts) on the distribution panel located in the living room. incorrect screws poses a safety risk for arching of electrical component. Recommend an electrician properly install (repair) correct fastening screws and further evaluate the wiring to circuit breakers within the main panel.

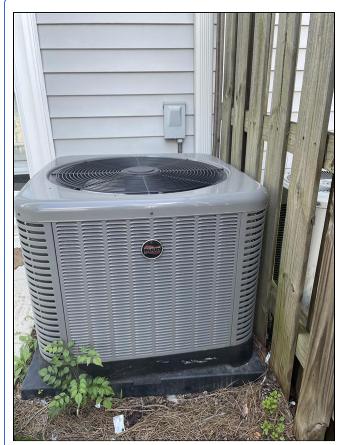
9.0 Item 1 (Picture) HVAC(located rear of residence)

Minor Defect: I observed a quick disconnect within proximity of the HVAC system. I observed HVAC (Rheem RP1436AJINA) manufactured in 9/2014 was too close to the fence. HVAC system requires proper clearance of at least 12 inches on all sides to allow for proper air flow. Due to the limitations of the fence location it is recommended that you monitor on a monthly basis to ensure no additional obstruction such as debris or environmental hazards such as leaves and limbs do not block the system.
